Condition Assessment and Strengthening Measured for Historical Building

Kirti Tiwari¹, Hima Shrestha² and Ramesh Guragain³

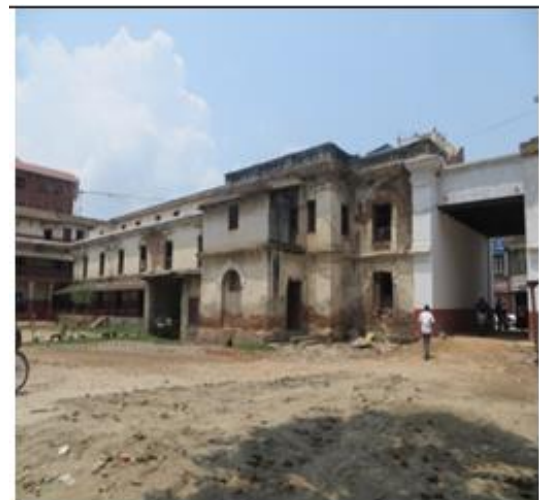
Fig 1:- Front View of the Building

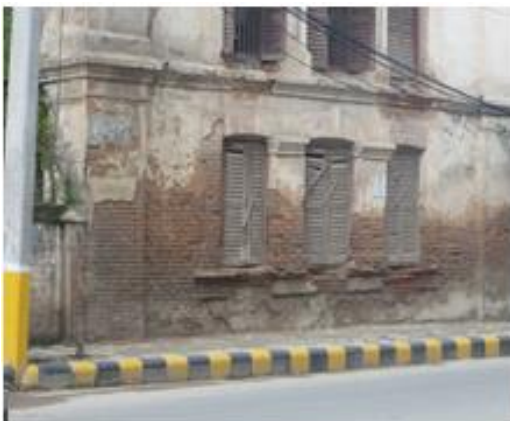
Fig 3:- Weathering of west wing outer wall

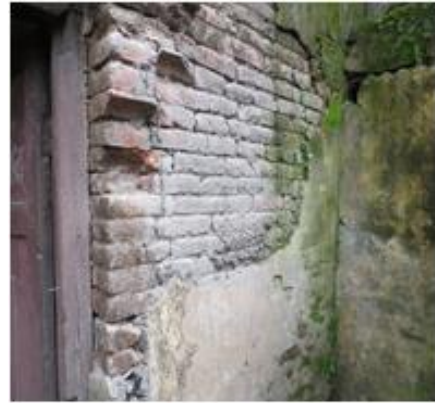
Fig 4:- Damages due to weathering of west wing outer wall

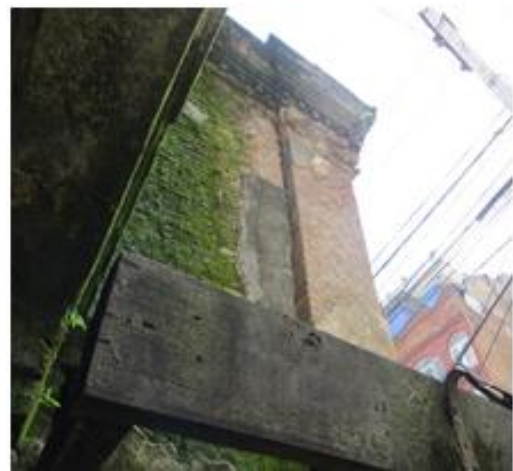
Fig 5:- Growth of plant in external wall of west wing

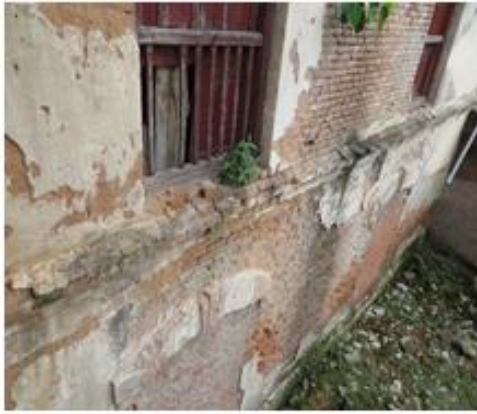
Fig 7:- Deterioration of brick of west wing outer wall

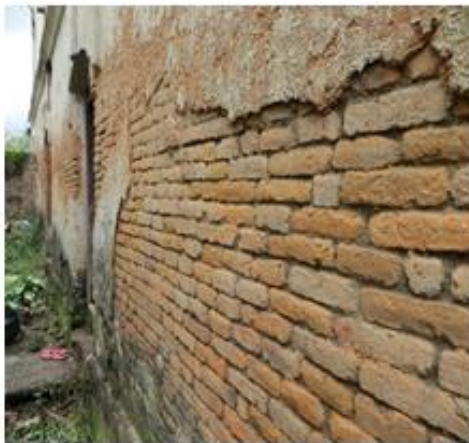
Fig 8:- Erosion of brick/mortar in external wall of North wing

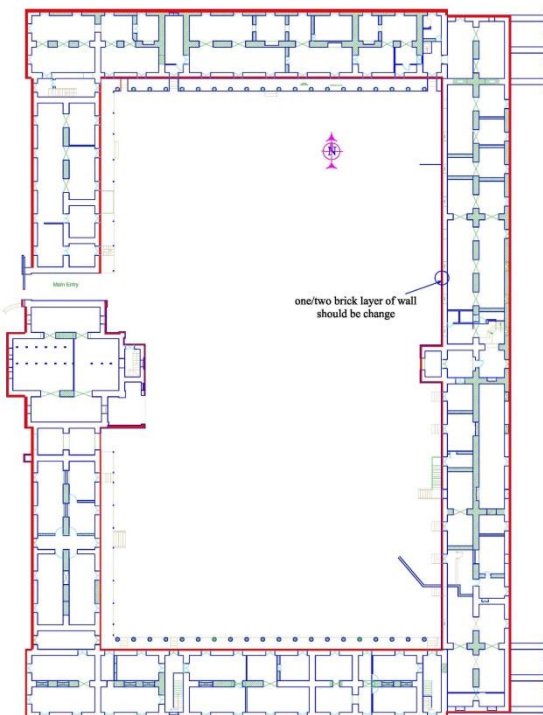
Fig 9:- Damage of outer wall in plan

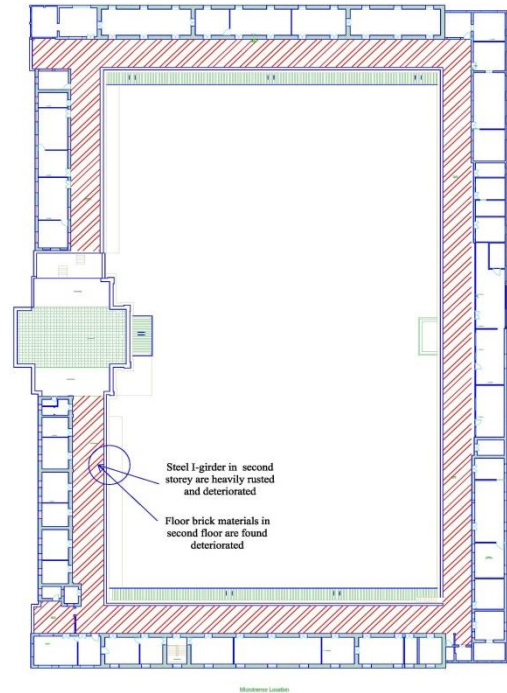
Fig 10:- Damage portion of roof in second floor

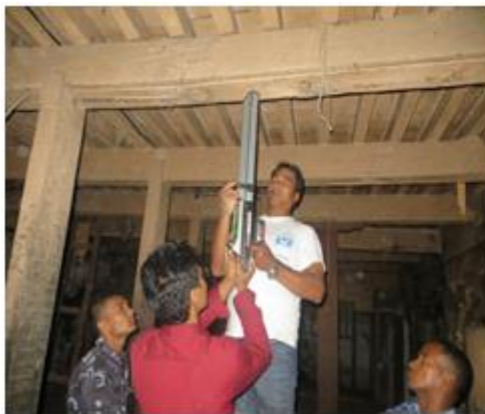
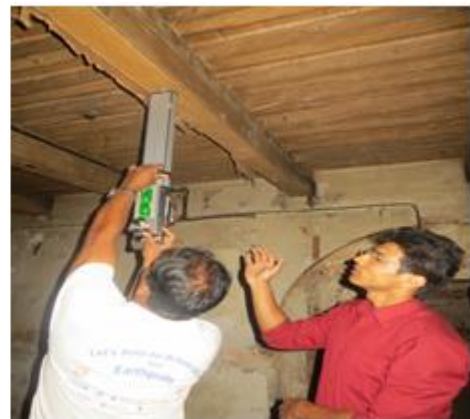
Fig 13:- Conducting Wood Decay Test using IML Resistograph PD Series in Charkhal Adda

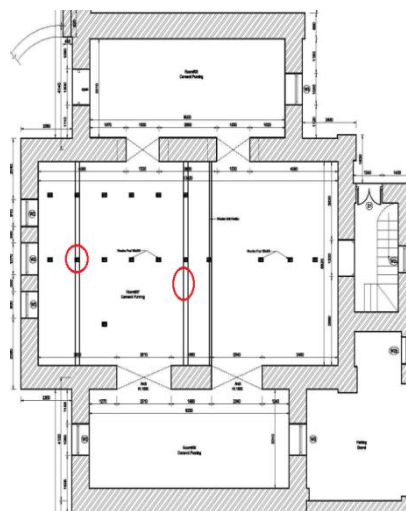
amplitude graphs represent the higher intact of wood. The test carried out only on the exposed wood surface at about 35 different locations. Very few beams found damaged. The location of damaged wooden beams and the test results shown in Figure 5.

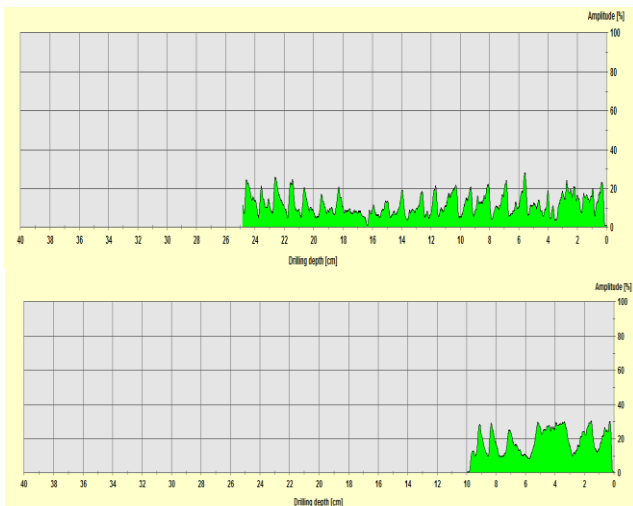
Fig 15:- Resistograph of beams with irregular surface

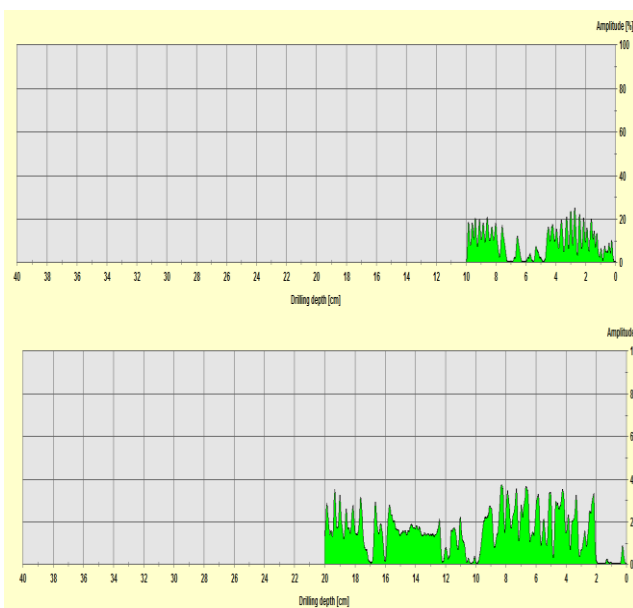
Fig 16:- Resistograph of decayed beams

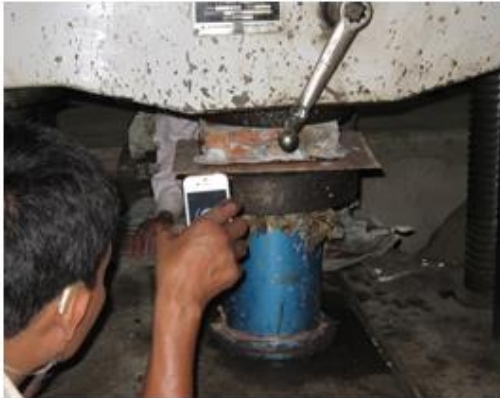
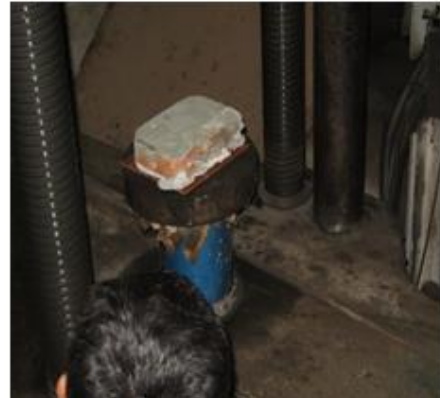
Fig 19:- Compressive Strength Test of Brick Unit

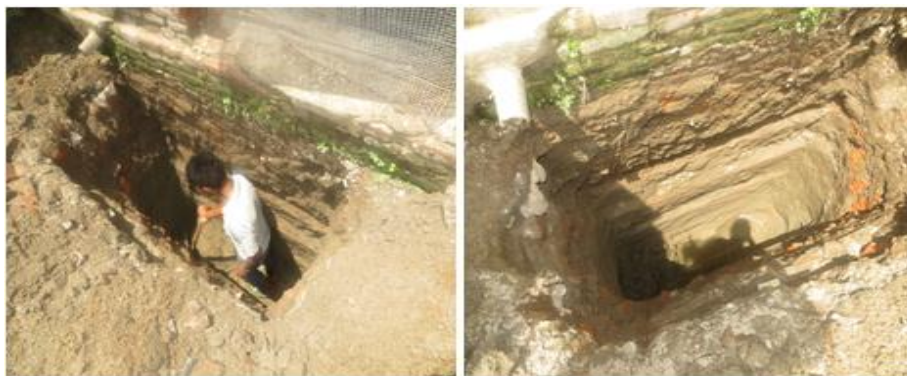
Fig 20:- Foundation Investigation in Charkhal Adda

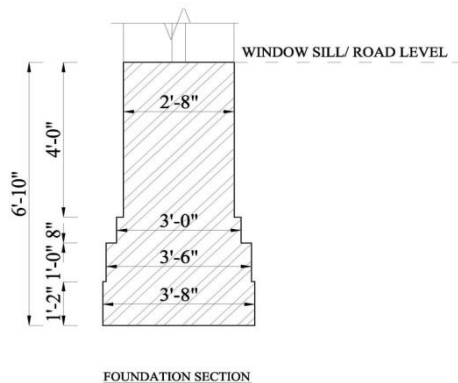
Fig 21:- Foundation Section of Charkhal Adda at inspected locations

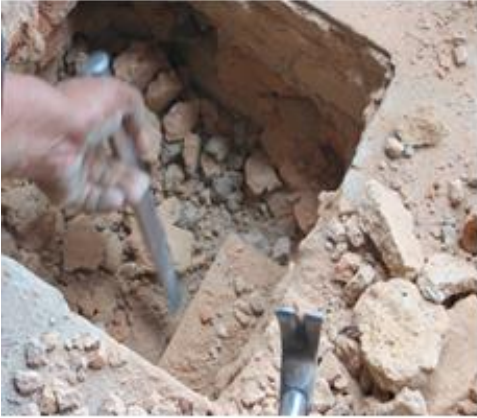
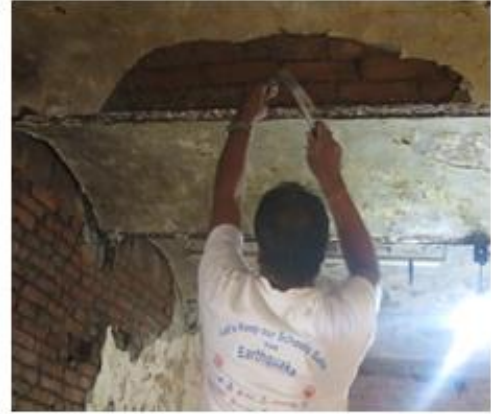
Fig 22:- Floor/Roof detail exploration in west wing of Charkhal Adda

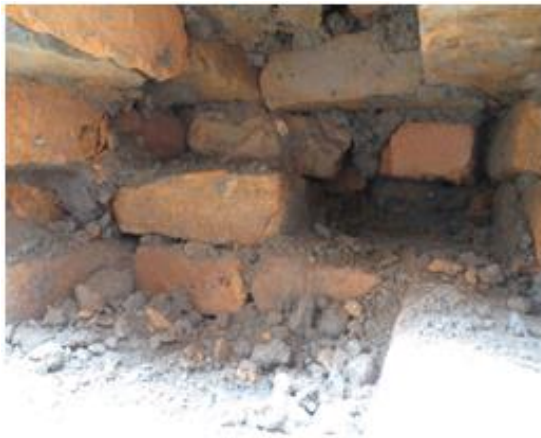
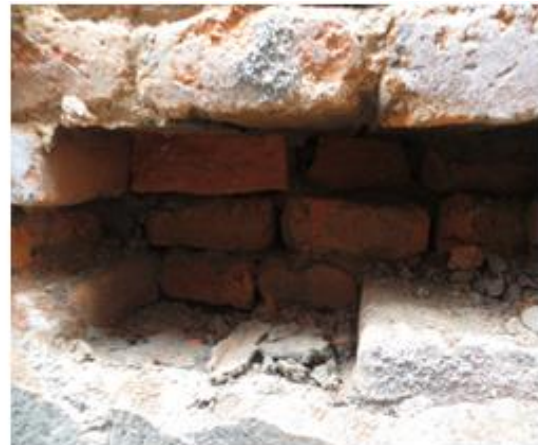
Fig 23:- Brick Lay Pattern in opening of wall

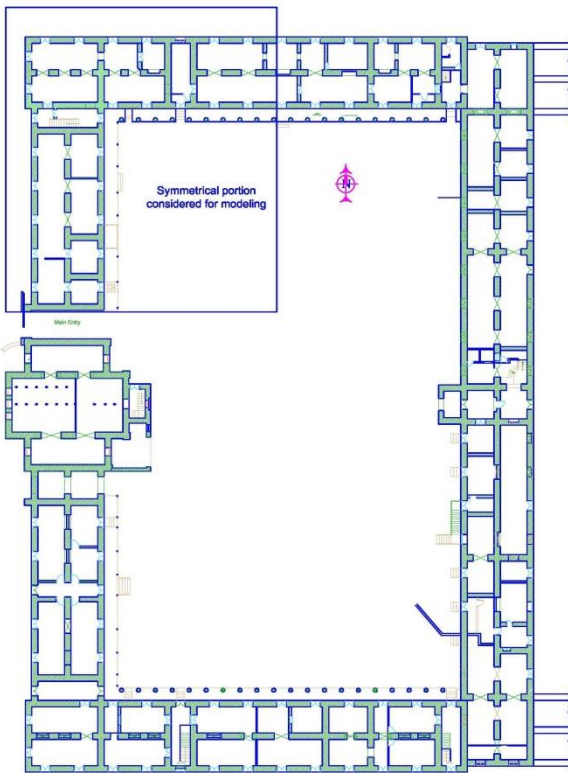
Fig 24:- Symmetrical portion considered while modeling (Ansys)

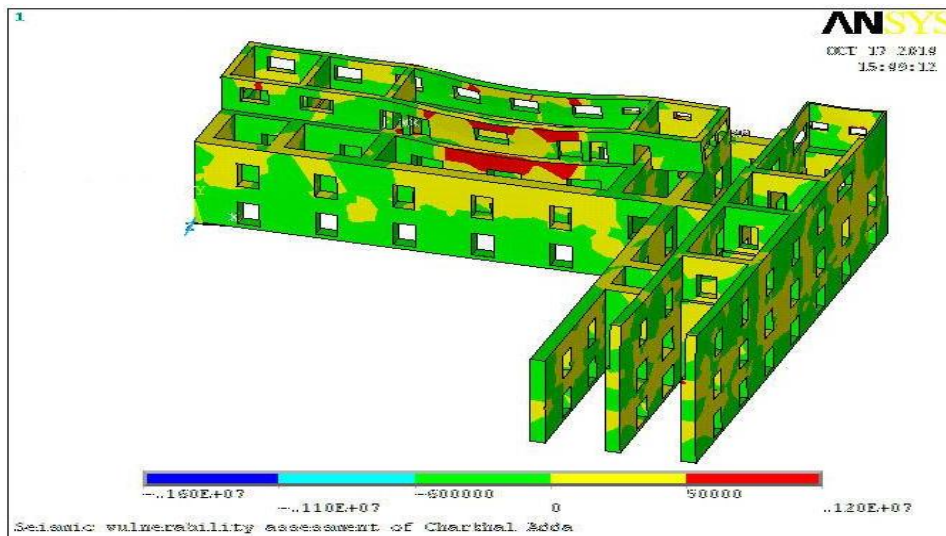
Fig 38:- Diagram showing normal stress (S_X) in building during earthquake in Neg-Z direction
