Effects of Bank Escapes and Floods in the Kavimvira Riverside Neighborhoods

Abstract:- The Kavimvira bridge destruction and riverine houses demolition along the two Kavimvira River banks during rain seasons 2015, 2016 and 2017 at Uvira, South Kivu Province, Democratic Republic of Congo (DRC), were investigated by direct observation and measurements of erosion areas. The study aimed erosion and inundation description, damages evaluation in order to prevent deaf for wildlife and for human beings. We found that river banks erosion and scouring inundations are the major threats of damages. We then suggest respecting ten metres from the river bank free of human activities, to reforest the Kavimvira river banks on both sides, to regularly dredge the river bed and to erect dykes for lasting environmental protection.

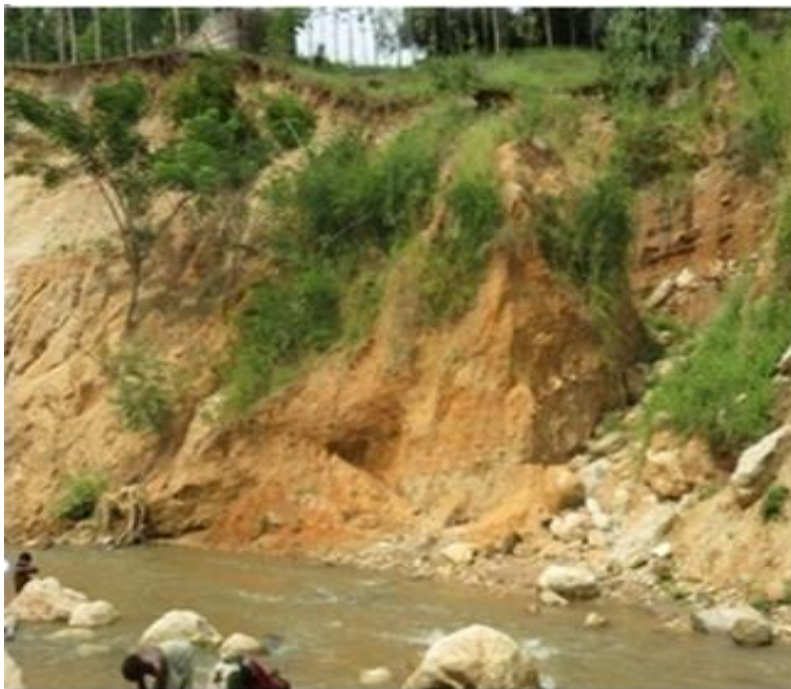
Fig 2:- Erosion on the right bank, upstream of the bridge: (742 m; 03 ° 2116.15 Lat South and 029 ° 0912.0 Long East) this shore presents major risks: completely threatened by erosion which is invading riverside constructions: some eucalyptus trees have already been washed away. Likewise, the sanitary facilities are threatened with destruction

➤ Photos 1, 2, 3,4 and 5 show the eroded banks and the associated destruction on soft sedimentary terrain with steep slopes of around 90 °.

The steep banks are attacked both by the river's sap, and by runoff and infiltration, followed by landslides or landslides. In certain cases, certain runoff waters follow the tracks used by the inhabitants; which accelerates the erosion process of the banks.

Hence the decline of the banks towards the collapsing riverside houses (photos 1, 2,3 and 4).

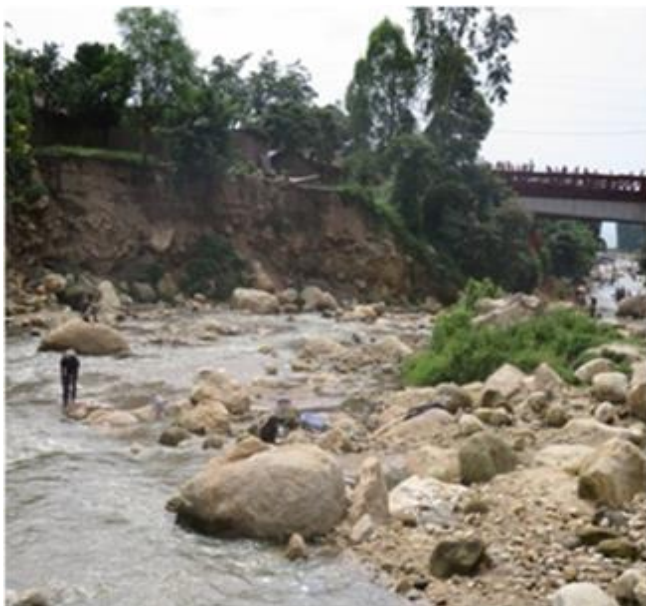
Fig 3:- Erosion on the left bank, upstream of the bridge: (03 ° 2115.3 lat. SOUTH and 29 ° 0914.4 Long. East). Shore at major risks. These houses, threatened with destruction, were established on this shore not 10 years ago. The population settled on this site for a permanent and regular supply of river water.

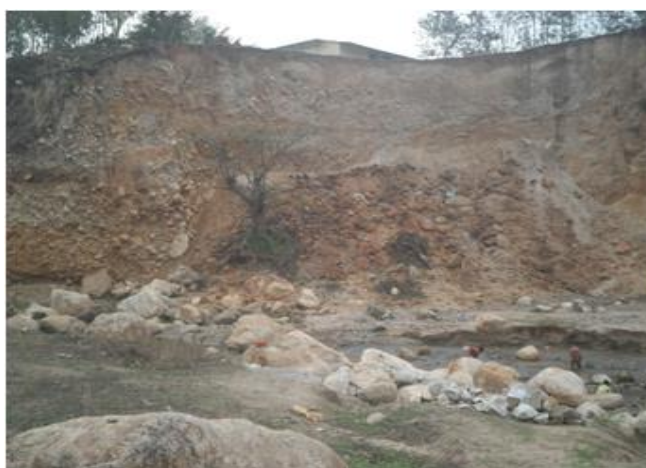
Fig 4:- Evolution of the erosion of Photo 1

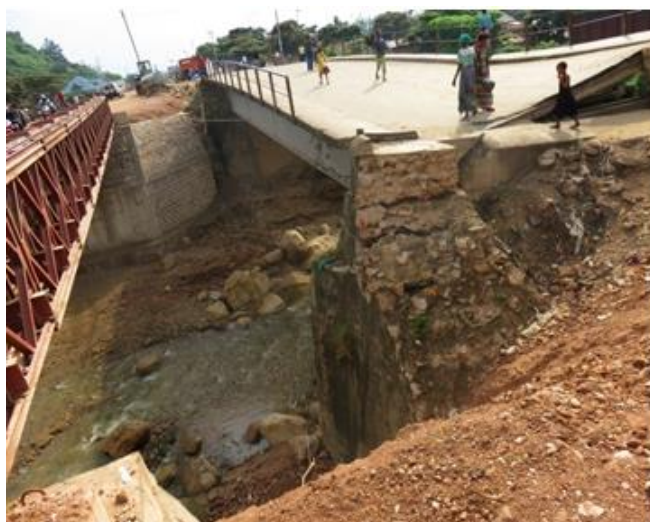
Fig 5:- Bridge collapsed on the RN5 on the right bank: (786m; 03 ° 21 '17,1lat. South and 029 ° 09' 15,8 East). This bridge was definitively damaged during a flood on the night of April 03 to 04, 2015. The RN5 serves the port of Kalundu on Lake Tanganyika: the country's second economic port after that of Matadi. Upstream of the destroyed bridge, a new erect

Similarly, the subsidence of the bridge on the right bank can be explained by the river and runoff water (photos 5).

These flow under the RN5 roadway and infiltrate between the foundation of the bridge and the loose sandy terrain to which the latter is attached. Indeed, when a pavement is poorly supported, it is particularly vulnerable to the action of runoff, from the moment when infiltration occurs under the bitumen (J- M. AVENARD, 1995).

Another part of the runoff flows at the edges of this foundation along the tracks of local residents.

These runoff waters played a major role in this subsidence of the bridge, because having prepared this mechanism. This is why, the bridge was definitively damaged, during a flood, after its foundation had been undermined at the base and lifted off the sandy ground of the banks.

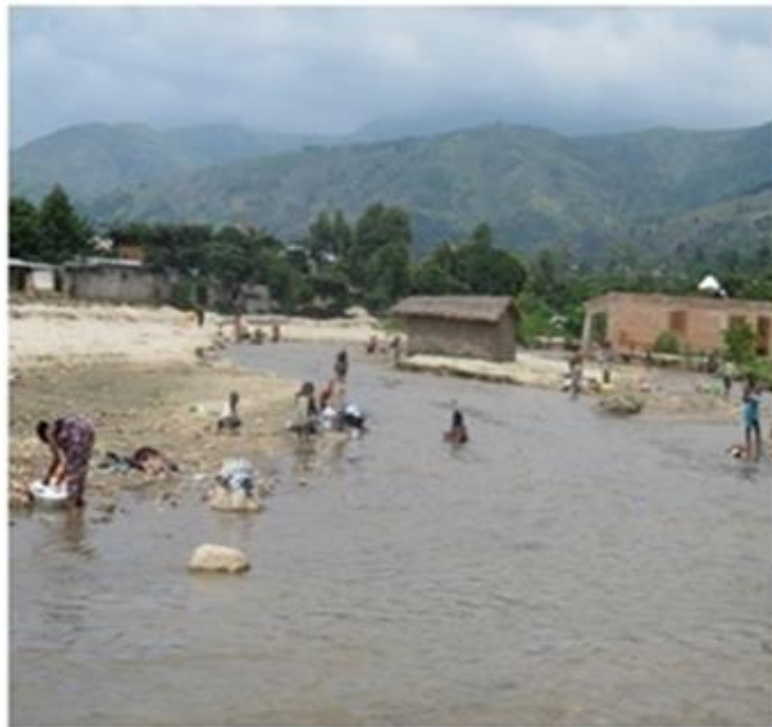
Fig 6:- Flooding and destruction of houses 774 m.

These two houses which resisted the destruction, obstructed the water diverted following the raising of the bed and the destruction of other houses. They then forced the river to deviate again to destroy other houses that were located where the sand and gravel sediments spread

➤ Photos 6 and 7 show the floods and consequent destruction, on a flat topography (774m above sea level). Some houses that have resisted destruction or partially destroyed, sometimes force the stream to deviate again.

These floods are successively linked to the sandy-gravelly alluvial deposits and to the raising of the river bed.

Indeed, the steeply sloping stream arrives in the almost horizontal alluvial plain, it raises its bed by sedimentation, it comes out of its bed with an erosive force such that it digs another in a lower position; this bed in turn will raise, the torrent will occupy another and so on (M. ORIA, 1963; M. DERUAU, 1974; G. NEUVY, 1991). Hence the instability or mobility of the bed. It is during the torrential crisis period that the river overflows after alluvialization : the channel is moved.

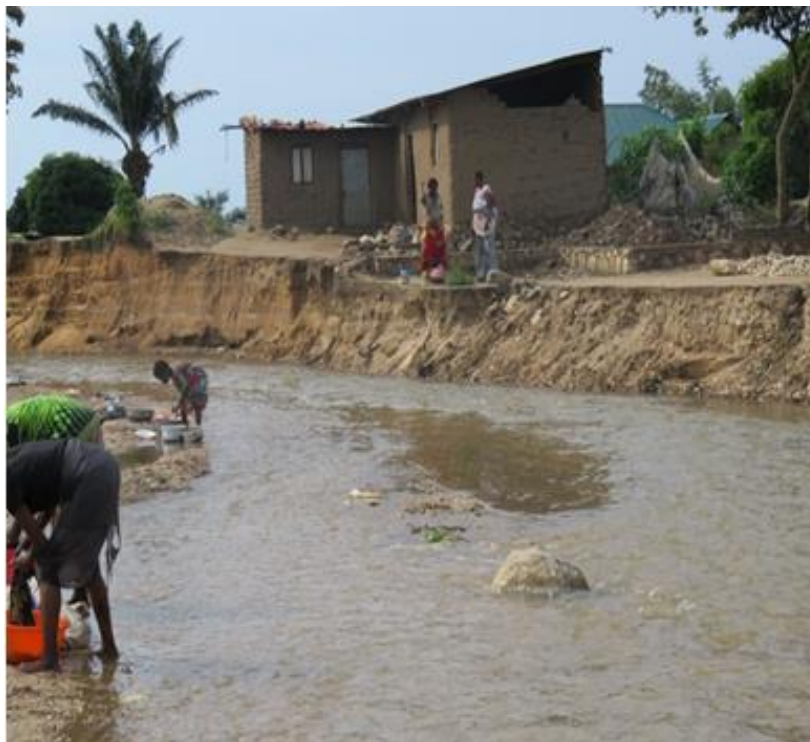
Fig 7:- Current bed (2017) after last migration from North to South. Bank erosion

Indeed, the mobility of the bed explains the successive destruction of the houses, one after the other, during recurrent floods. Photo8, about thirty meters upstream from the mouth, shows a certain stability of the current bed in 2018 after migration to the South.

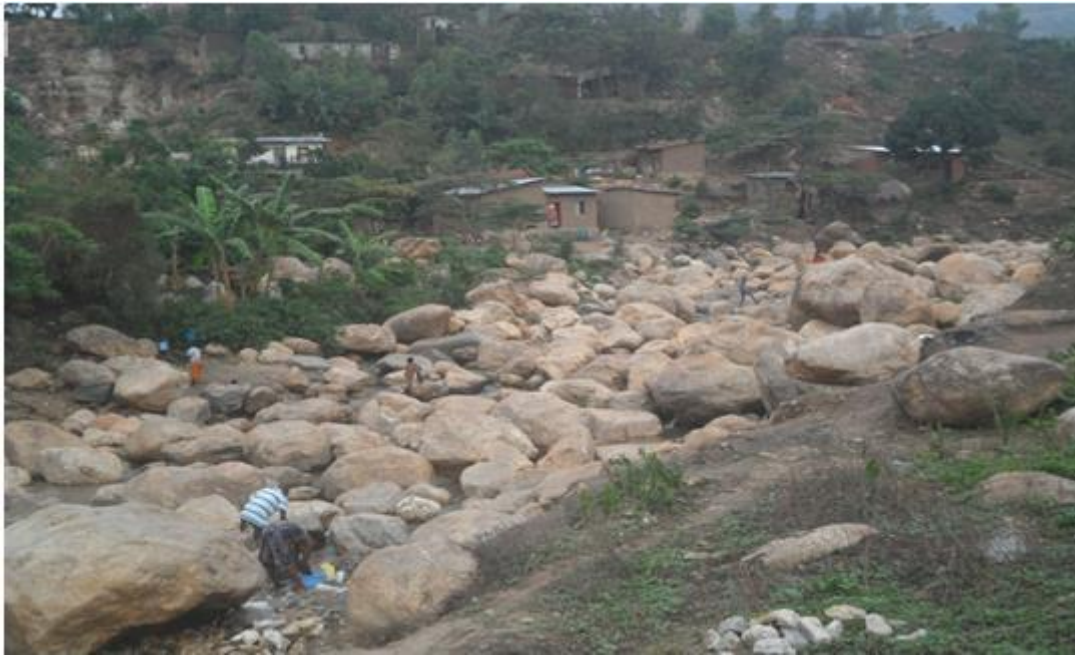
Fig 8:- These houses built on the right bank at the foot of an old terrace.

They are exposed to the risk of floods and landslides. These blocks, of metric dimensions, were deposited during the torrential crisis in April 2015 and 2017. They reflect the competence of this river.

➤ Human or local influence is not negligible in these destructions (photos 1, 2, 4, 6 and 9): its anarchic constructions along the banks exposed to the risk of landslides and recurrent floods. Likewise, paths or tracks used as routes and leading to the river favor the erosion process of the banks, because they are often so traveled by rainwater.
