# Potential Failure Causes of Newly RC Built Structures in Kabul, Afghanistan

**Abstract:-** This investigation puts emphasis on the potential failure causes of newly RC structures (buildings) in Kabul city. Since Kabul city has been experienced rapid growth problem due to unexpected urbanization. However, great number of building structures are required for the housing, industrial units, commercial buildings, and other infrastructure. In keeping with the Kabul municipality, the major product of these recently built buildings in the Kabul city is of RC structures. Although, very few of them are constructed after approval and accordance with the standards. The technique performed in the assemblage of data comprises the distribution of questionnaires to technical specialists in the structural activities as well as case studies for the building sites. Simple Random Sampling method was conducted for choosing the sites visited. For selecting structural professionals, relevant organizations such as Kabul municipality and MUDH, Ministry of Urban Development and Housing were consulted. Graphic statistical method such as ranking of failure sources with against the participant's feedback wa

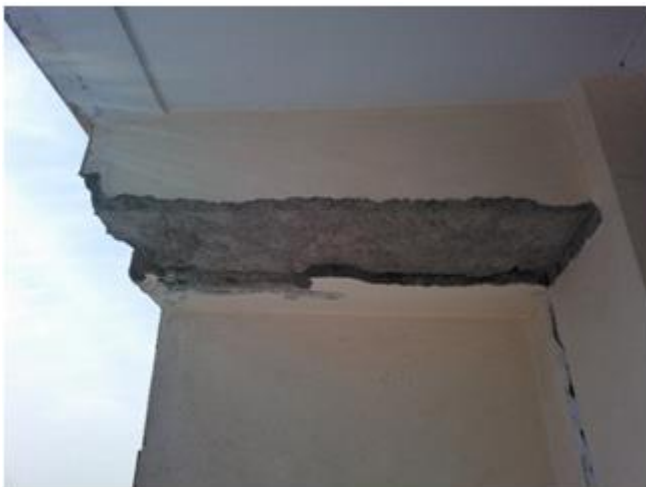
In the sequence of site visits for inquiry of the case study data as stated in the above lines, on Saturday 11, 2, 2017 a site visit was conducted (first case study) in Polytechnic University campus which is ideally the part of the estimated case study area that was selected for the inquiry. In this campus, some of the buildings were technically inspected representing the others. Among all well-suited buildings, one of the buildings was sensibly affected nearby the expansion joints. Removal of finishing and other cladding from exterior faces of the members indicated that they are seriously stressed by some unexpected ampules. Fig 2.3

Figure 2-3 Beams nearby the joint, indicates pounding by unexpected ampules.

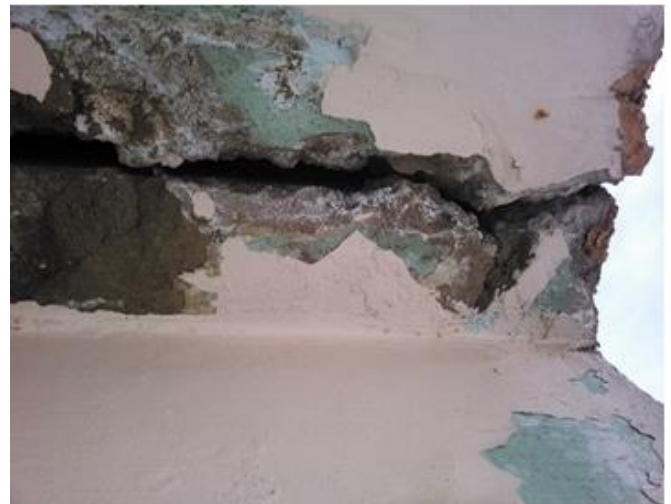
Expansion joints are normally designed and intended to prevent mid-separated parts of the structure from contiguity of each other while excessive stress and movement is produced at the time of thermal change, wind sway as well as in dynamic responses during seismic activities in the buildings. Investigations found, that after the October 2015 Hindu Kush earthquake a magnitude 7.5, the main members such as beam and columns nearby the proposed expansion joints were seriously pounded to each other. Technically analyze of the proposed occurrence indicates that the joints are principally to be treated by using the soft and smooth substance (expanded polystyrene) in

order to only cover the joint appearance rather than to keep them in touch such as a motionless manner, were filled by some unsuitable and hard materials (shotcrete and concrete particles). The inquiry found that the maintenance for buildings which is normally to be done was not considered as appropriate as it was required, since it is common when the earthquake shaking is occur the materials used between the separation joints (polyethylene) are occasionally removed due to weathering reactions so it is appropriate to be treated again by the same substance Fig 2.4

Figure 2-4 Expansion joint treated by improper materials (shotcrete and mortar)

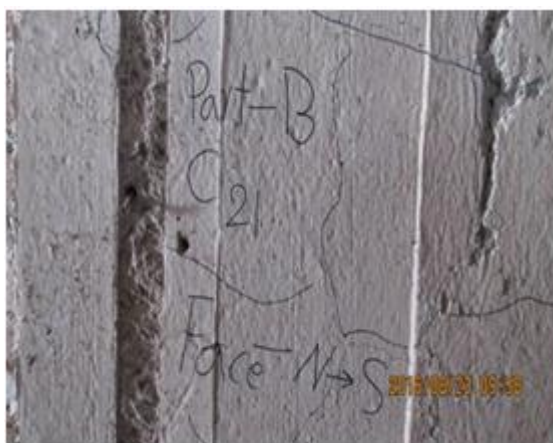
Due to the recent fire, all main elements of the building have been received serious cracks, in some of the members this faults are considerably visible. Column no.8 and 21 for floor four are good examples Fig 2.9 & Fig 2.10

Figure 2-9 Shows cracks on the 21st column

All those buildings they are subjected to fire should be examined and inspected in a professional means to assess the extent of damage and prevent further disasters in reuse of the structures. The author suggests the government agencies responsible for controlling construction activities in Kabul city for forming the forensic engineering section in
