Alluvions and Flooding of Waters in Uvira (Dr Congo)

Abstract:- The present work, carried out during the years 2000 to 2020 in rainy seasons, aims to describe the impact of excessively abundant alluvium on the flooding of rivers in Uvira. From direct observation of the facts in the field, we have shown that the raising of the beds of the rivers and the obstruction of the outlets of the water of the rivers by too abundant alluvium, are two factors. Which condition the flooding of rivers observed in the city of Uvira for several years?

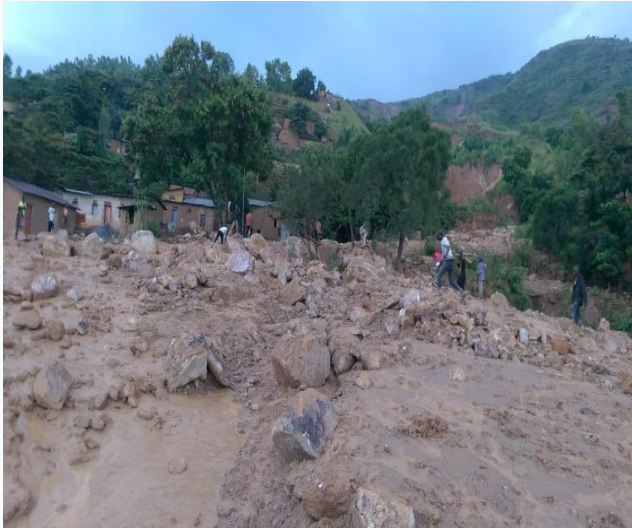
Fig. 2 Torrent Nyarumanga (03 ° 23'99"S; 29 ° 08'12"E. 860m)

Torrent known for its recurrent flooding. Torrential alluvium still made up of blocks, pebbles and clayey mud. This alluvium was deposited during the flood of 23/04/2020, which had the effects: 8 houses buried by alluvium and 10 destroyed houses. Spreading of alluvium In May 2018, this torrent caused material and human losses including 4 deaths, children from the same family who slept in their beds.

- **Blocks:** The accumulations of blocks, often associated with pebbles, dominate in certain streams above (fig. 2 and 3) and others: Ruzozi, Sangeza, Nakagonjwa,... These are quartzite blocks of decimetric size to metric: the largest of 6.90m thick was observed in the Mulongwe river, at the foot of the mountains where the latter empties into the plain. These blocks reflect the strong energies of the current of these rivers. The quantity and size of the elements transported is a direct result of the speed of the current. This depends on two main factors: the slope of the land and the volume of moving water (Laverdiere J.W. et al. 1959).

Indeed, the rivers, very laden with alluvium in rainy seasons, raise their beds and flow to a higher level than the surrounding regions: the water overflows and inundates the regions occupied by human habitat (2, 3 , 4 and 5). This overflow of water is accompanied by the mobility of the bed and consequently the destruction of homes (Ilunga L. 2006, Mwenyemali et al. 2020).

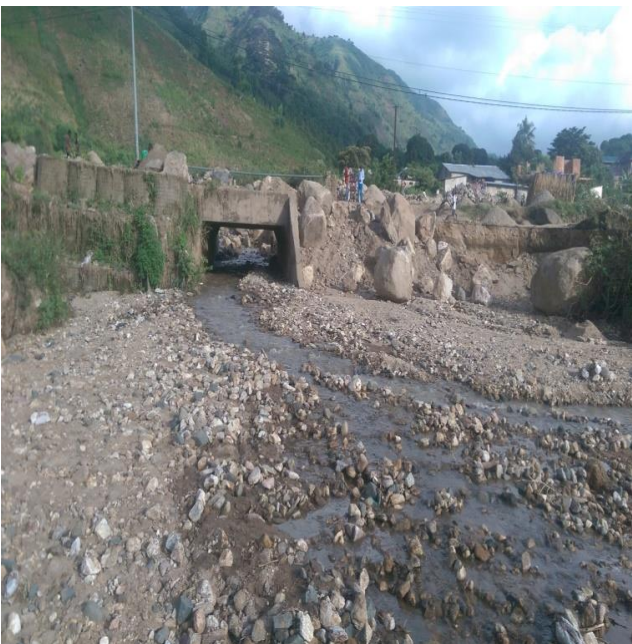
Fig. 3 Torrent Kamongola (03 ° 25'48"S, 29 ° 07'51"E. 796m)

These blocks and pebbles were deposited during a flood in April 2020. This torrent is famous for its disaster of February 2002, the results of which were heavy: more than 50 dead, and a lot of material damage (houses destroyed, RN5 barred by big blocks for two weeks: no access to the lake port of Kalundu.

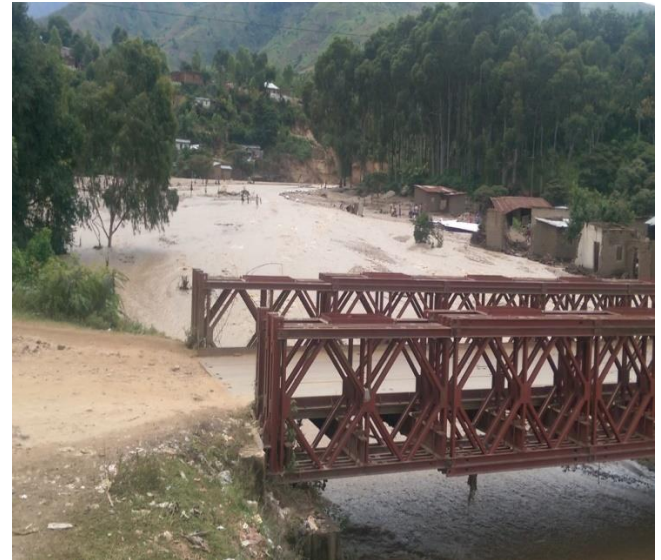
Fig.4. Rivière Kavimvira (3°32'47''S; 29°15'89, 9''E. 788m)

Intense accumulation of sand and gravel, upstream and downstream of the bridge, during the flood of 04/17/2020. Here, the human habitat and a small market are located upstream of the bridge on the left bank. Before the flood, they were at a higher level than the minor bed. After raising the bed, they were flooded and flooded with sediment. Subsequently, the market was completely buried and the habitat is at a much lower level in bed because of sedimentation. Likewise, the bridge, which was 4.50m above the water, is already at 2.40m. Spreading of alluvium.

- **Sands:** Characterize other rivers, including fig. 4 and 5 and others: Kalimabenge, Kaala, Nyangwi,... Sometimes gravelly sand is observed. Particle size analysis shows that these are sands with various grains, mainly coarse sand (500 μ -1mm) with a large percentage of medium sand (250 μ -500 μ) and very coarse sands (1mm-2mm).

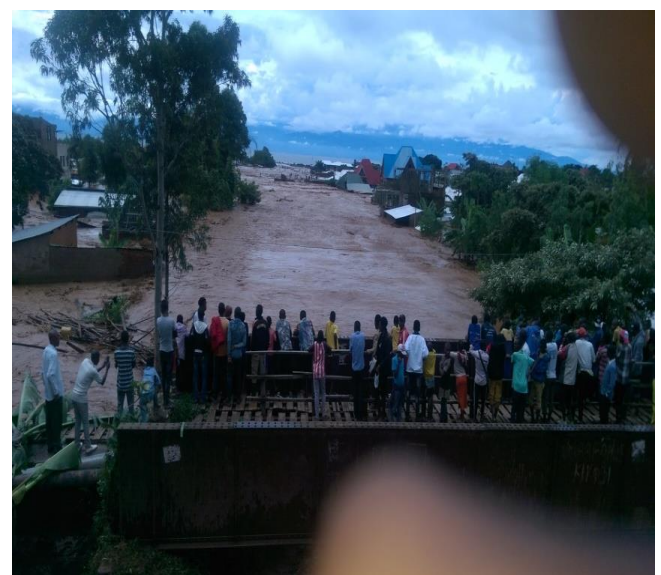
Fig.5 Rivière Mulongwe (03°20'18, 7''S; 29°09'30"E. 787m).

The river raised its bed by sandy-gravelly alluvium during the flood of 04/17/2020, and it is already above the level of the habitat. We observe the spreading of alluvium.

These floods linked to the obstruction of the fluvial and torrential flow nozzles are observed in a recurrent manner in most of the rivers of Uvira (fig. 5 and 6), Karigo, Kagenge, Kibondwe.

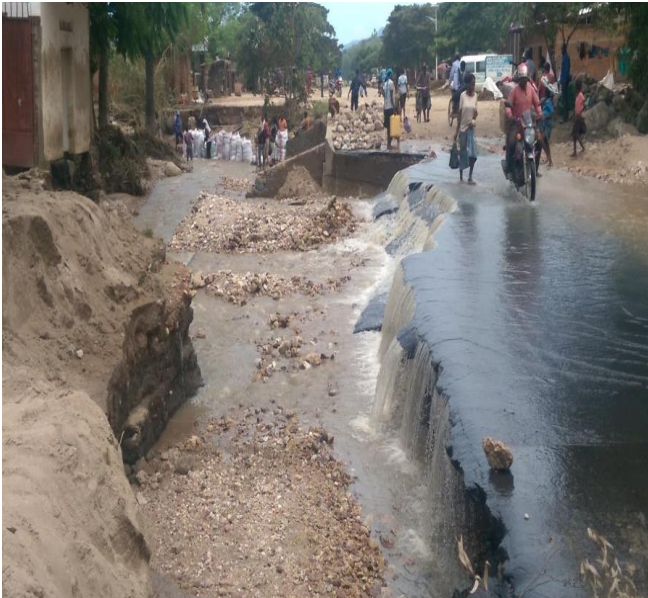
Fig.6 Torrent Kaala (03°12'45, 7''S; 29°09'34, 4''E. 806,7m).

Torrent with recurrent floods. In April 2000 the alluvium (sands, gravel, pebbles and boulders) blocked the nozzle, below the RN5, and forced the water to overflow over the RN5. We observe the degradation of the RN5 and the houses located downstream of the bridge.

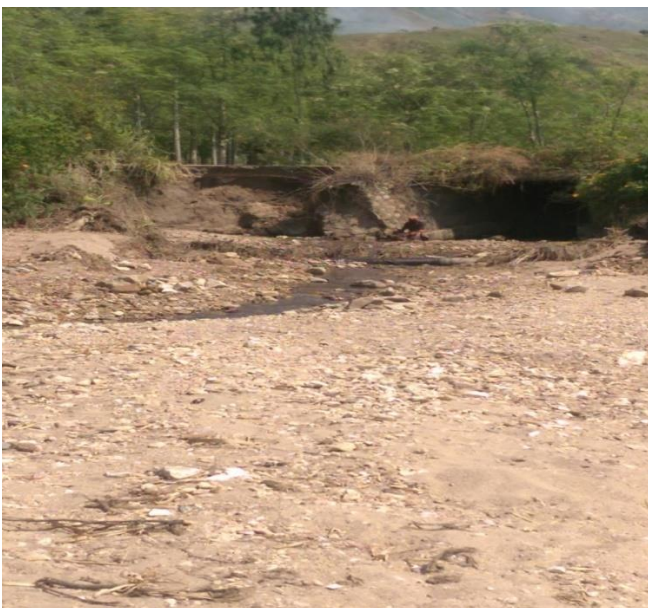
Fig.7 Torrent Rutemba (03°18'9, 1''S, 29°9'36, 4''E. 814m)

Torrent with recurrent floods. After obstruction of the nozzle below the RN5, by alluvium in April 2000, the water overflowed and resulted in the erosion of the RN5

and the gullyng of a citrus plantation located more towards the right bank downstream . Spreading alluvium.
